## Joint Section 1

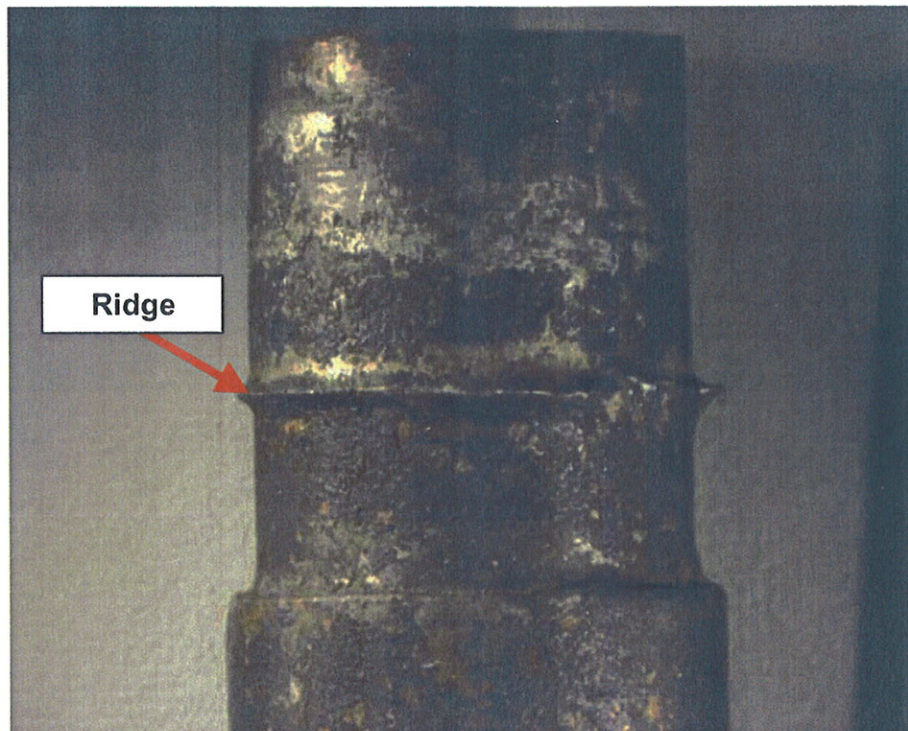
Joint Section 1 is the portion of copper tubing that was soldered to the female brass valve fitting. A stereomicroscope image of Joint Section 1 is shown in Figure 9. The prominent feature on this section of copper tubing is the ridge that circumnavigates the tube. This ridge is shown at a higher magnification in the SEM image in Figure 10. EDS analysis was performed in the regions denoted by the red boxes labeled "1" and "2" in this image. The spectra acquired from this analysis are shown in Figure 11 and Figure 12. The likely source of the carbon peaks in these spectra is soot or other carbonaceous material deposited during or after the fire. The source of the oxygen peaks is likely metal oxides. The primary metallic elements present in these regions are tin and copper, which indicates that this ridge is composed of solder.

Figure 9. Stereomicroscope image of Joint Section 1.

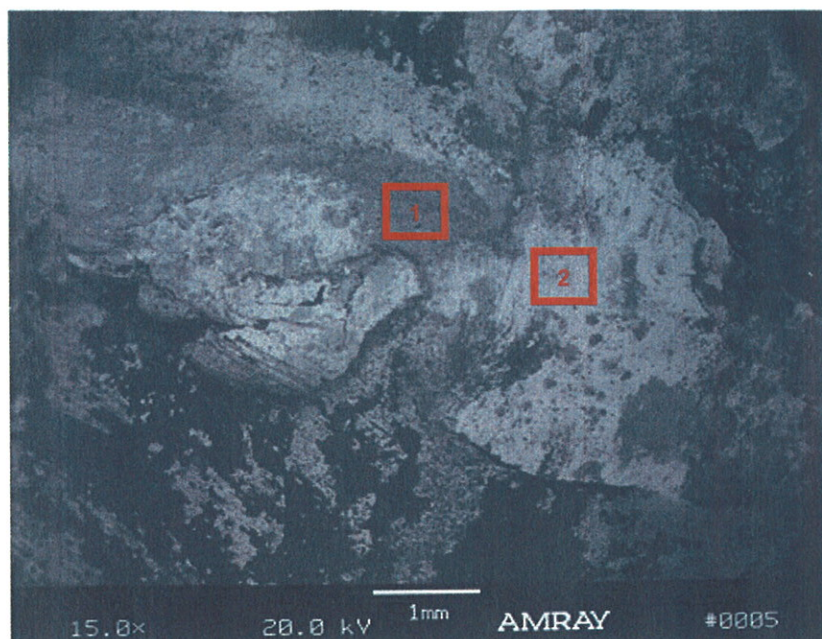
Figure 10. Backscattered SEM image of the ridge on Joint Section 1. EDS spectra acquired from the regions in the red boxes are shown in Figure 11 and Figure 12.

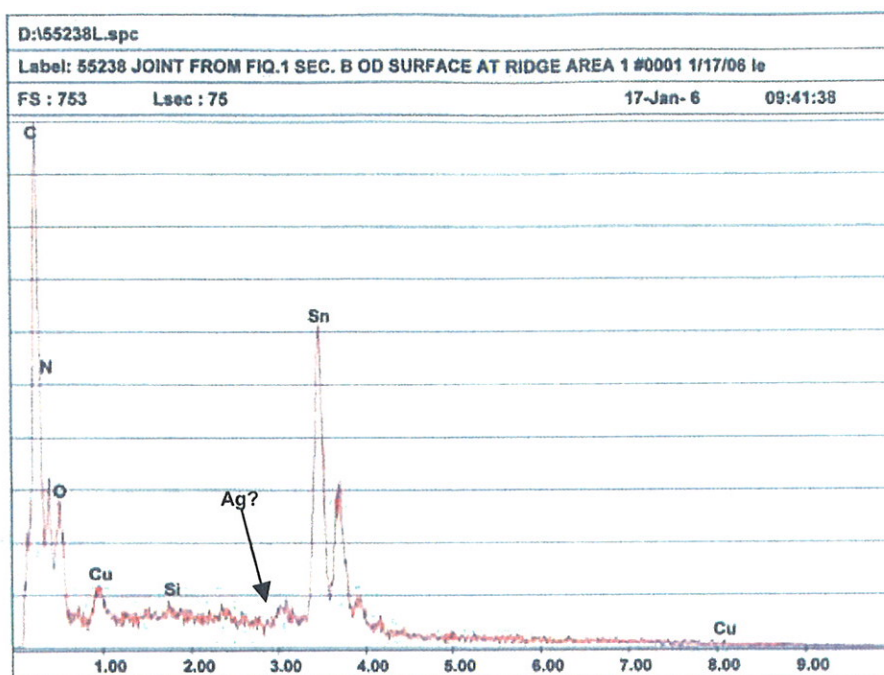
The conversations with the plumber who initially installed this pipe indicated that he typically used Canfield "100% Watersafe" or similar brand solder. According to the manufacturer's MSDS, the composition of this solder is 95% tin, 4% copper and 1% silver, by weight. While both tin and copper are present in the spectra in Figure 11 and Figure 12, silver is not detected. Unfortunately, the most intense silver peak has an energy of 2.98 eV, which overlaps with one of the low intensity tin peaks. The approximate location of the silver peak is indicated in both spectra. As a result of this peak overlap, and the relatively small amount of silver in this alloy, EDS cannot confirm the presence of silver in this solder. The presence of the lead peak in Figure 12 is interesting because "100% Watersafe" and other plumbing solders are lead-free alloys; therefore, the lead must come from another source.

Figure 11. EDS spectra of the region inside red box #1 shown in Figure 10.

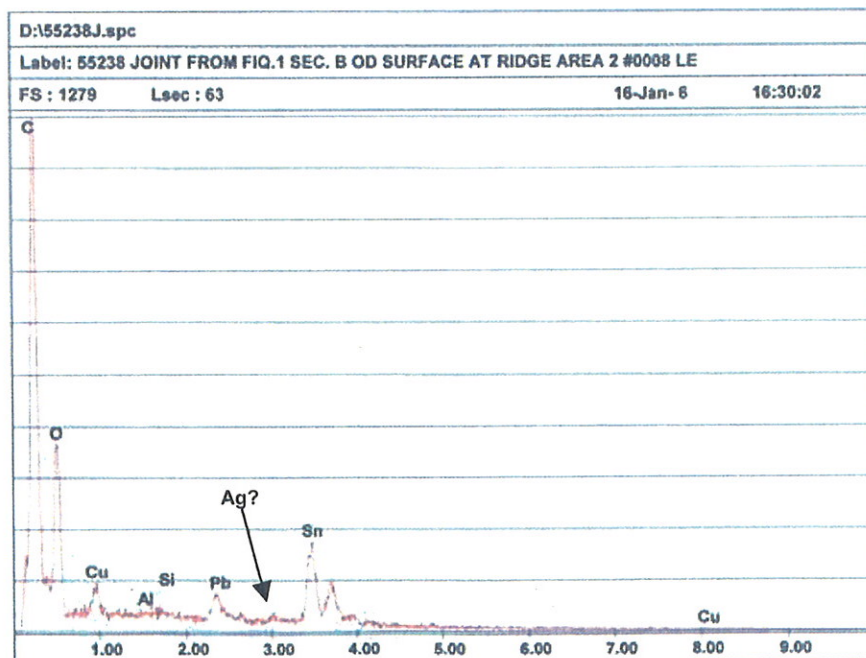
Figure 12. EDS spectra of the region inside red box #2 shown in Figure 10.

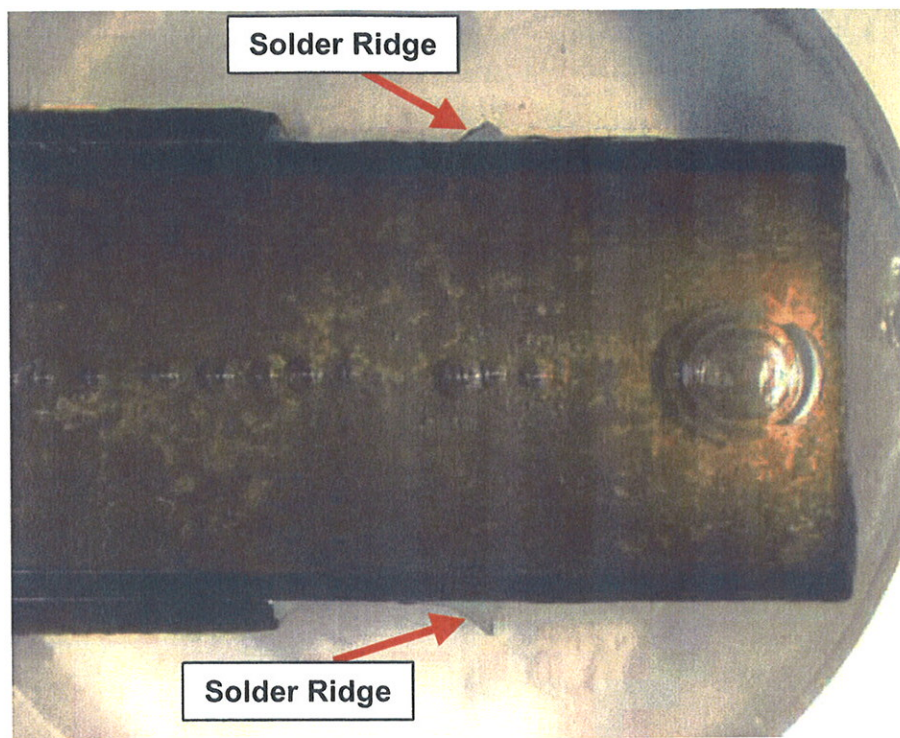
This section of copper tubing was cut parallel to the axis of the tube and metallographically prepared so that the cross-section of the copper/solder interface could be investigated. A stereomicroscope image of this cross-section is shown in Figure 13. The ridge of solder can be clearly seen on both sides of the cross-section. This ridge is shown at a higher magnification in Figure 14. It is very interesting to note that the ridge of solder appears to have retained its original shape and still comes to a rather sharp point. The shape of this solder ridge indicates that the solder was not molten when joint was separated. If this ridge of solder had melted, then surface tension would have caused the ridge to lose its original shape in order to reduce its surface area.

Figure 13. Stereomicroscope image of the polished cross-section of Joint Section 1.
